**Anderson v Wal-Mart**

## **Anderson v Wal-Mart**

July 21, 2017

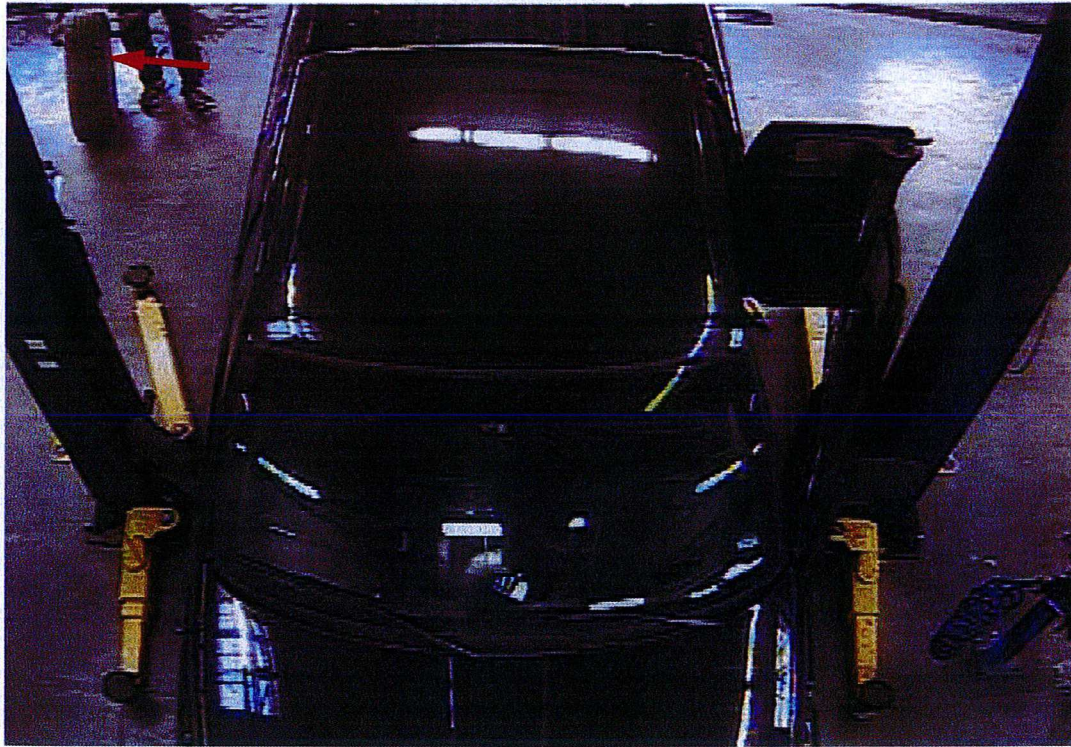
- b. 02:43:49 – A tire that was subsequently rolled towards the front of the subject vehicle and outside the camera view, has four (4) distinct rain grooves (circumferential channels), and appears to be bulging slightly over the rim, Figure 1.

- c. The wheel on which the four-groove tire is installed appears to be gray or dull silver in color.
  - d. No visible oxidation or discoloration consistent with steel oxidation was observed on the wheel rolled from the back of the truck.

Figure 1. The tire that was rolled from the back of the truck has four (4) distinct circumferential rain grooves.

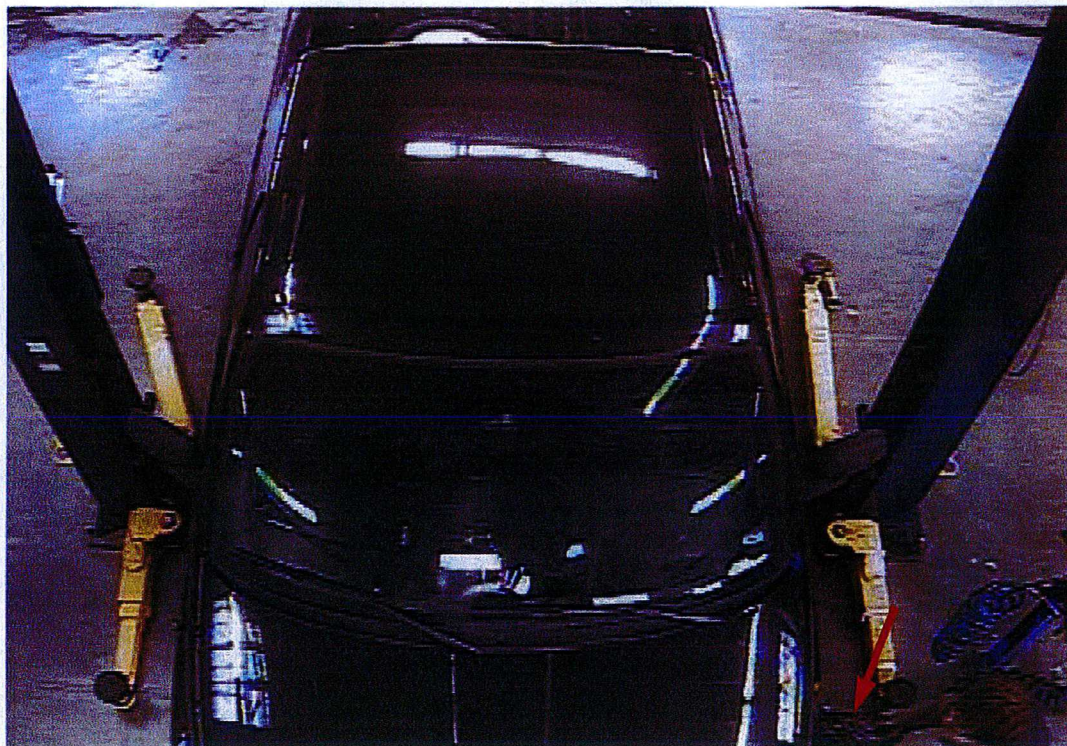
- a. The mounted tire was observed to have four (4) distinct circumferential rain grooves.

Figure 2. The tire that was installed on the left front has four (4) distinct circumferential rain grooves.

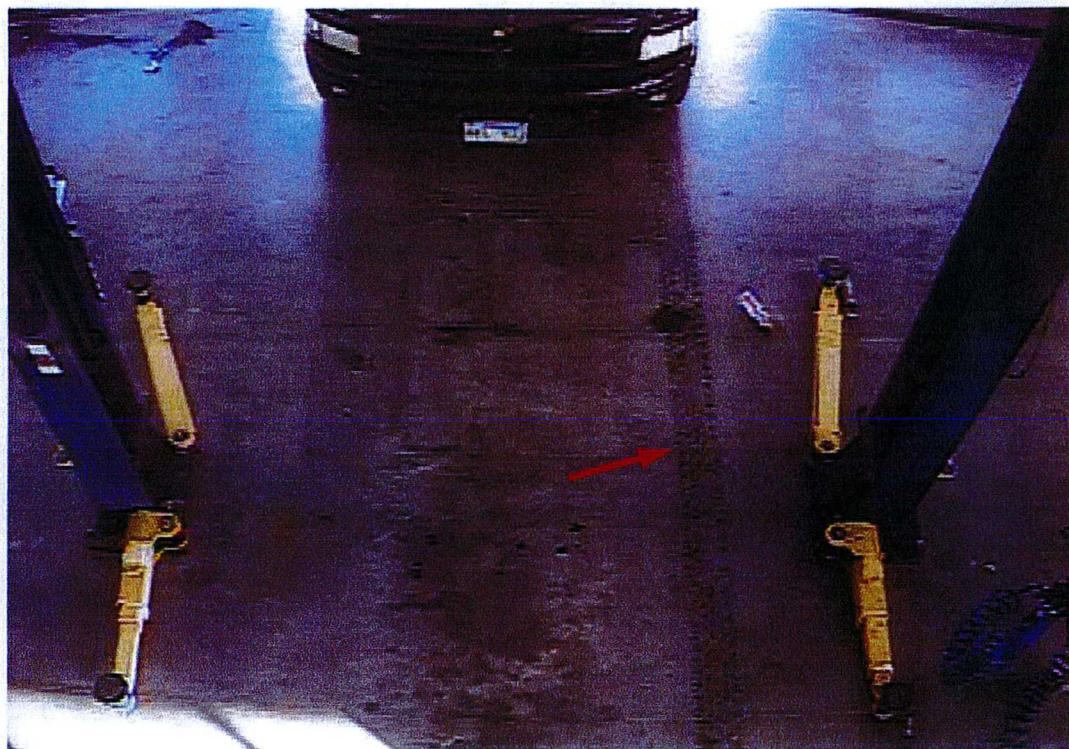
- a. The left front tire left a trace on the concrete floor, Figure 3.
  - i. Four distinct channels can be observed in the tire trace pattern.
  - ii. The edge of the tire trace is consisted of distinct tread blocks (patches), i.e. not a solid tire shoulder.

Figure 3. The track left by the left front tire as the vehicle was reversed out of the bay has four (4) distinct grooves and shoulder blocks separated by the transverse grooves.

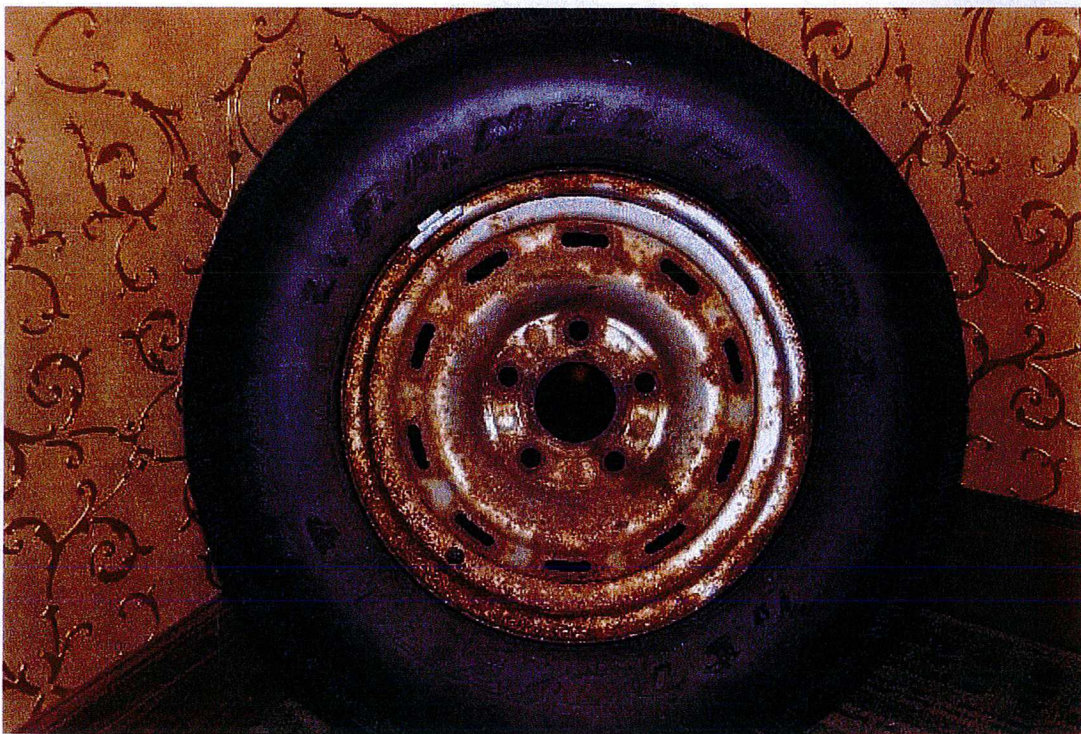
On May 23, 2017, FFESC inspected the tire and wheel that reportedly detached from the subject truck. The front of the inspected wheel is shown in Figure 4, while the rear side of the wheel is shown in Figure 5. The inspected wheel is a five-lug steel wheel. The wheel exhibited corrosion and scaling on both the rear and the front. However, the rear side appears significantly more corroded than the front side of the wheel. The inspected tire virtually did not exhibit any bulging over the rim.

Figure 4. Front side of the wheel and tire that reportedly detached from the subject vehicle.

The corrosion pattern on the front side of the wheel around the center bore is approximately uniform around the center bore hole (Figure 4). In addition, the corrosion of the wheel is significantly more pronounced on its rear side than on the front. This is not consistent with the spare wheel being suspended under the vehicle for a prolonged time.

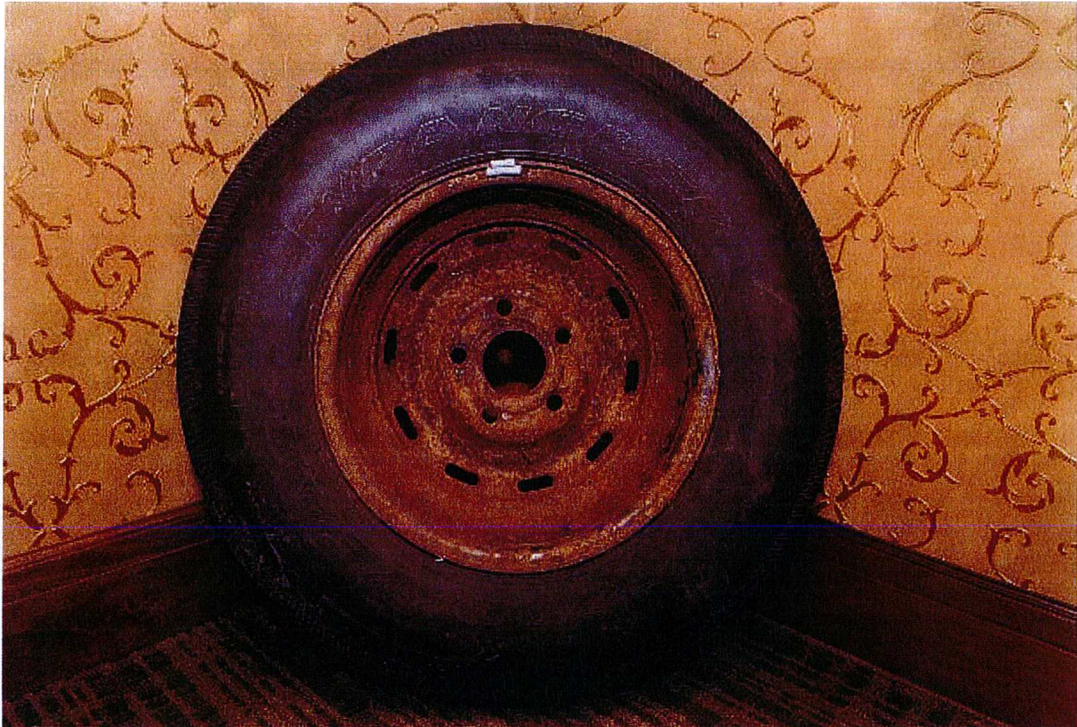
Figure 5. Rear side of the wheel and tire that reportedly detached from the subject vehicle.

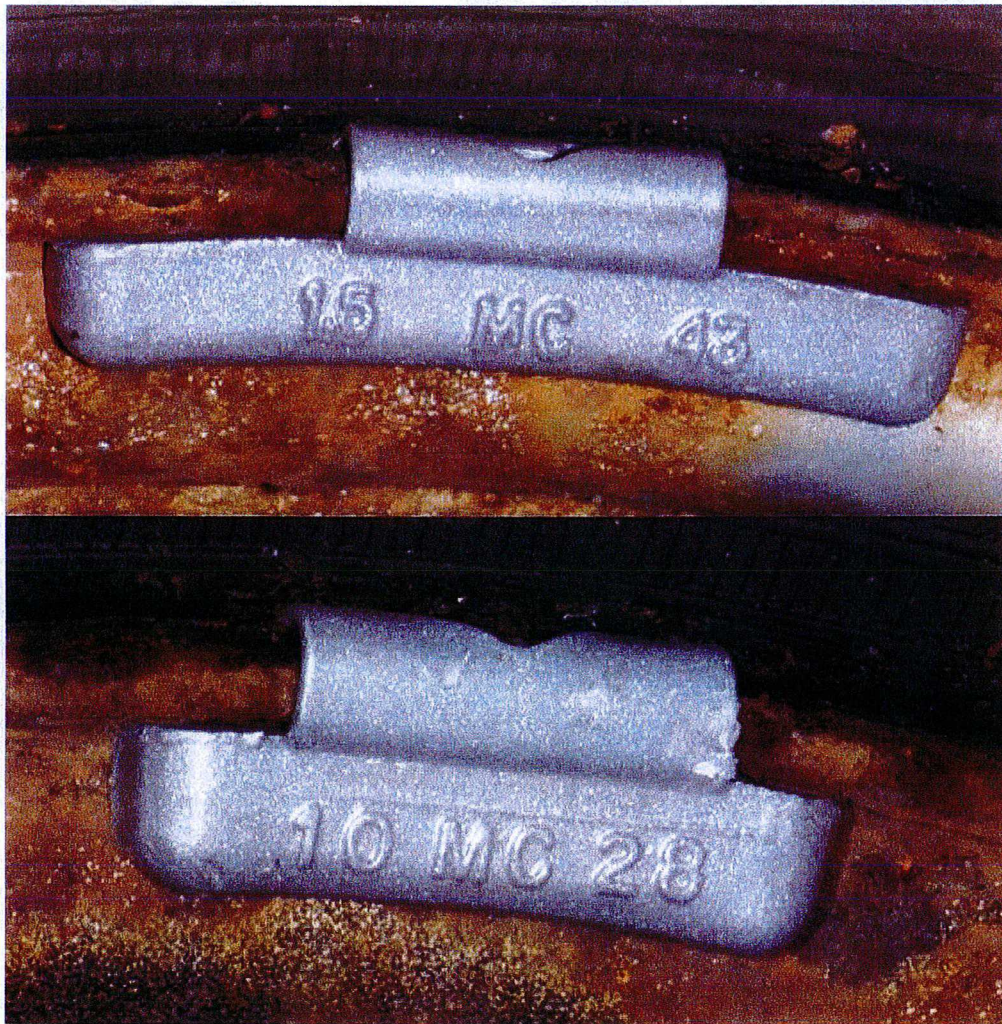
Two wheel weights were observed installed on the inspected wheel. Both wheel weights are attached to the wheel using MC style clips, Figure 6. The wheel weight installed on the rear side of the wheel has the following markings: “10 MC 28”. This indicates that this wheel weight weighs one (1) ounce or twenty-eight (28) grams, and uses MC style clip for wheel attachment. The markings on the wheel weight installed on the front side of the wheel state: “1.5 MC 43”. These markings indicate that this wheel weight weighs one-and-a-half (1.5) ounces or forty-three (43) grams, and that it also uses MC style clip for wheel attachment.

The appearance of the wheel weights attached to the inspected wheel indicates that they were not in service or attached to the corroded wheel for a prolonged time. Both wheel weights appear clean with virtually no damage or material degradation. In addition, their appearance indicates that they were made from a compliant material such as lead or zinc. However, it is important to note that neither wheel weight has any markings that would signify material of construction, which is typical for wheel weights made from zinc or steel. For example, the zinc wheel weight would have a “ZN” mark on it. Based on the information gathered to date, typical industry

Figure 6. Wheel weights observed on the inspected wheel (top: front side of the wheel; bottom: rear side of the wheel).

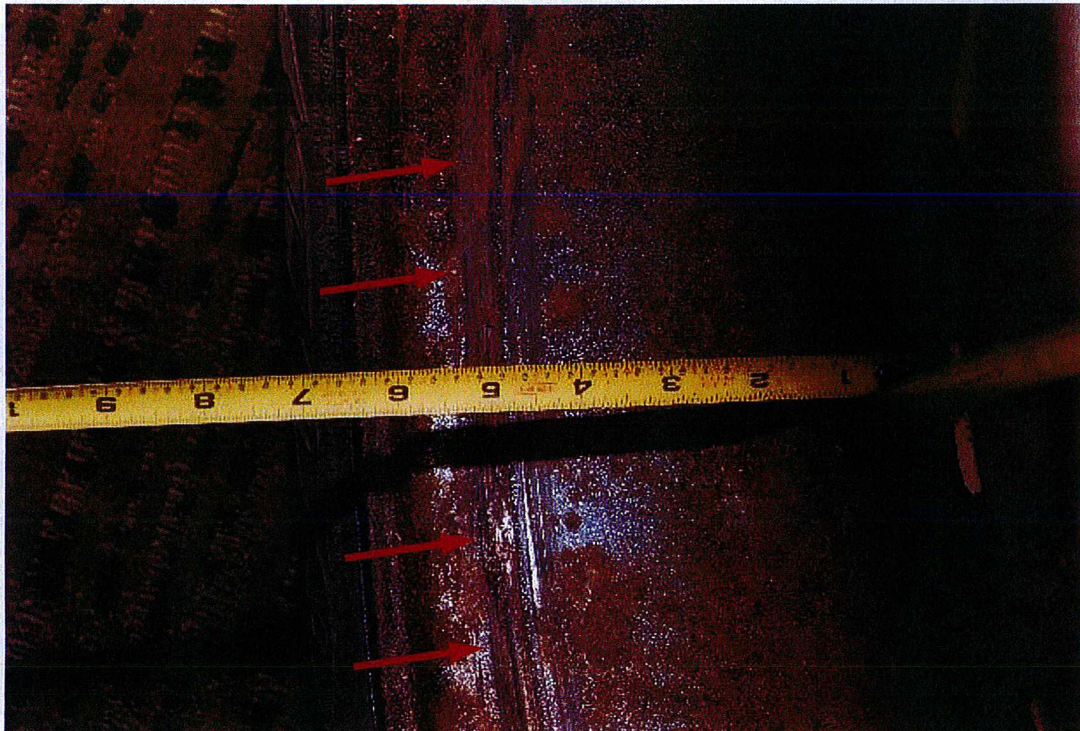
Circumferential witness marks were observed on the internal surface of the wheel rim, Figure 8. These marks are consistent with the rotor contacting the internal surface of the wheel rim as the wheel detached from a vehicle. Additional witness marks consistent with the wheel detachment were observed in the lug nut holes on the wheel itself. The surfaces of the lug nut holes have distinct thread imprints from contact with the studs, Figure 9. This contact is only possible if the lug nuts loosen sufficiently to allow the wheel to ride on the stud threads.

Figure 8. Witness marks observed on the internal surface of the wheel rim consistent with rotor contact.

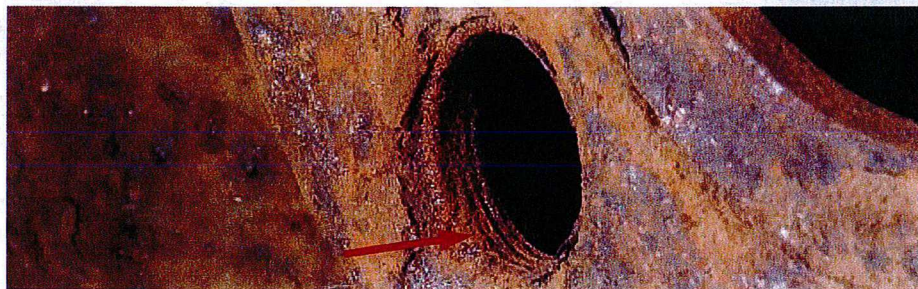
Figure 9. Witness marks observed on the internal surfaces of the lug nut holes consistent with stud thread contact.

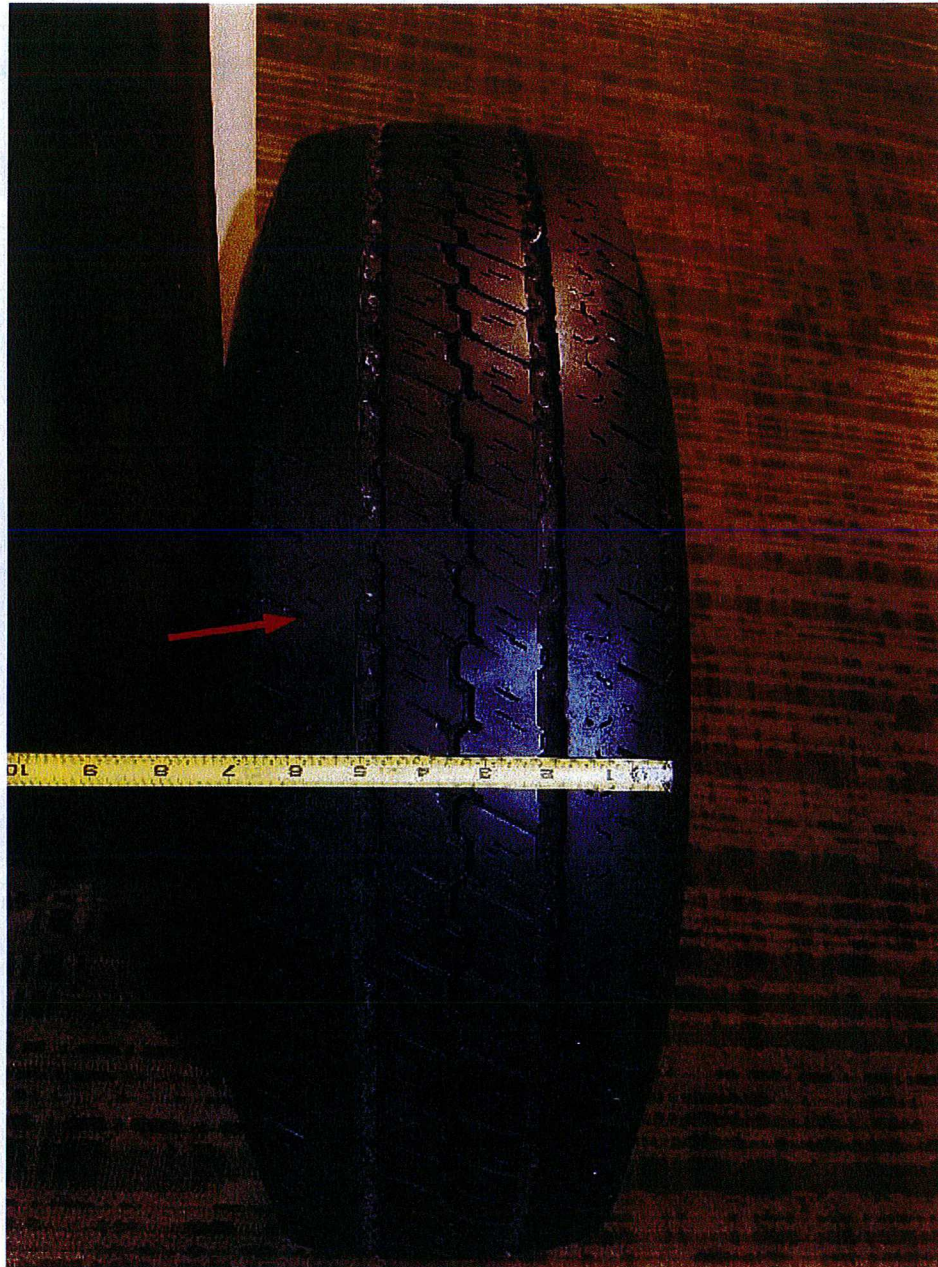
The inspected tire tread pattern is consisted of two main circumferential rain grooves and a narrow center circumferential groove, while the tire shoulder consists of a solid circumferential track with transverse grooves that penetrate only partially into the solid circumferential track, Figure 10. The observed tread pattern on the inspected tires is significantly different from the tread pattern of the spare tire that was rolled from the rear of the subject vehicle to the front (Figure 1). The tread pattern of the inspected tire is also significantly different from the tire that was installed on

Figure 10. Tread pattern on the inspected tire. Note, that the transverse grooves only partially penetrate the tire shoulder tread pattern, and do not separate the tire shoulder tread into separate blocks.

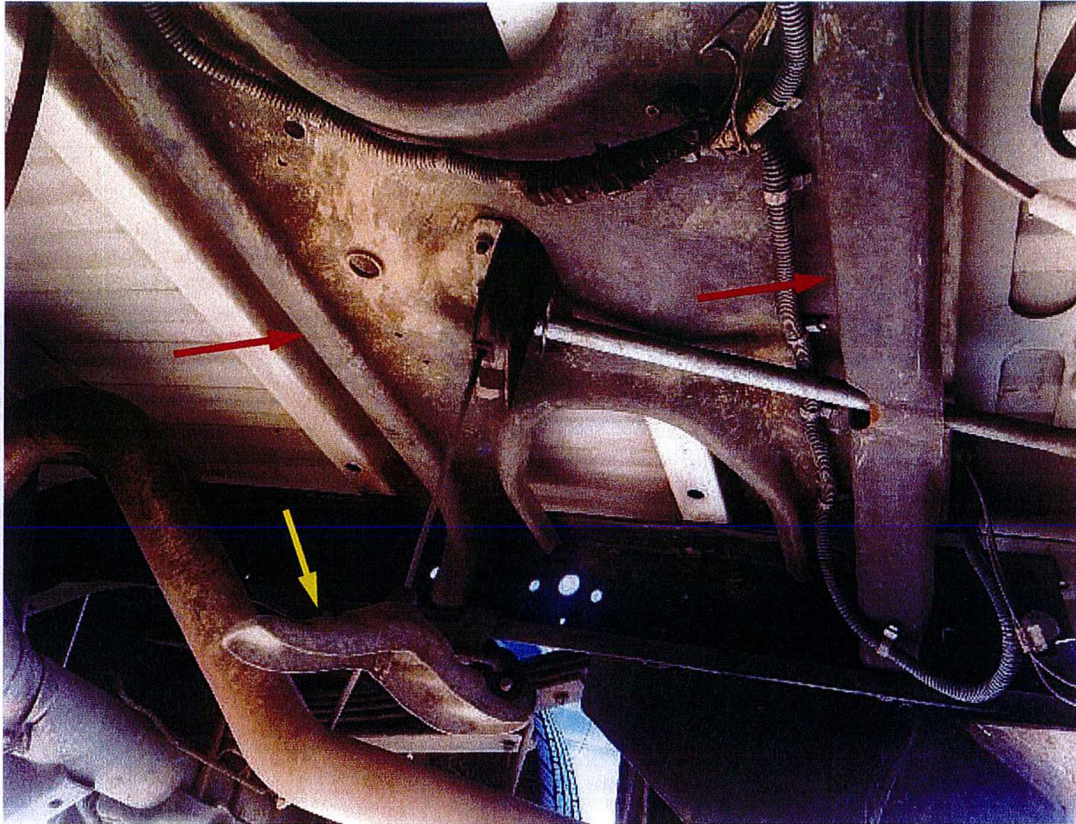
The front side of the wheel is pulled underneath the rear of the truck using a rectangular clip and cable mechanism, Figure 11. In this configuration, the front side of the wheel is facing the roadway and would be subjected to the corrosive media, while the rear side faces away from the roadway and would be somewhat protected from interacting with the corrosive media splashing from the roadway. In addition, the appearance of the inspected wheel is not consistent with the appearance of the wheel that was rolled in the surveillance video from the rear of the subject truck.

Similarly, when the spare tire is stored under the vehicle, the tire interacts with two transverse frame rails located underneath the cargo bed, Figure 11. The two frame rails typically result in the tire sidewall indentation when the spare tire is stored underneath the vehicle for a prolonged time. The inspected tire did not exhibit witness marks consistent with indentation resulting from interaction with the frame rails. This also indicates that the inspected tire was not stored underneath the vehicle for a prolonged time.

Figure 11. Spare tire mechanism on a 2001 Dodge 1500. Note the rectangular clip (yellow arrow), and the transverse frame rails (red arrows).

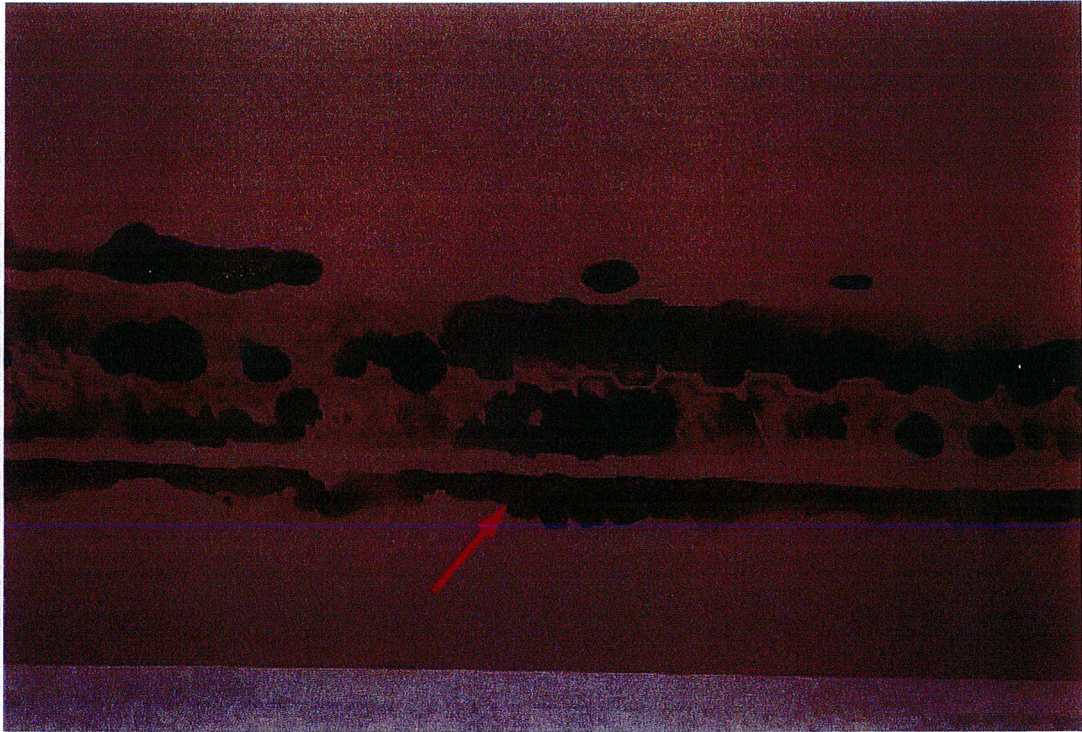
The inspected tire was tested to evaluate its tread pattern track. The tire was wetted and rolled over the painter's paper on which it left a track, Figure 12. The track left by the inspected and tested tire consisted of two (2) circumferential rain grooves, narrow center circumferential groove, and a solid shoulder trail on both sides. The test shows that the track left by the inspected tire is significantly dissimilar to the track left by the front left tire observed in the surveillance video. The test results indicate that the inspected tire is not the tire that was installed on the left front of the subject vehicle.

Figure 12. Tread track left by the inspected tire on the painter's paper. Note the solid shoulder track, as opposed to the block (patch) track observed in the surveillance video.
